Haewai Creek Walk - *Reimagining Houghton Valley*

12 November 2023

A 100 Year Vision for Haewai / Houghton Valley

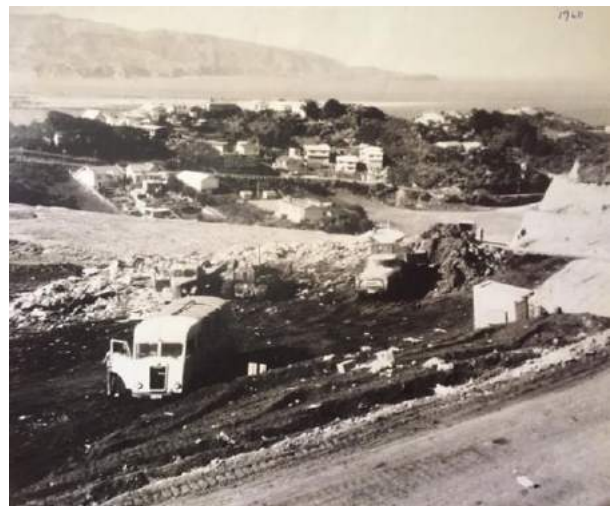
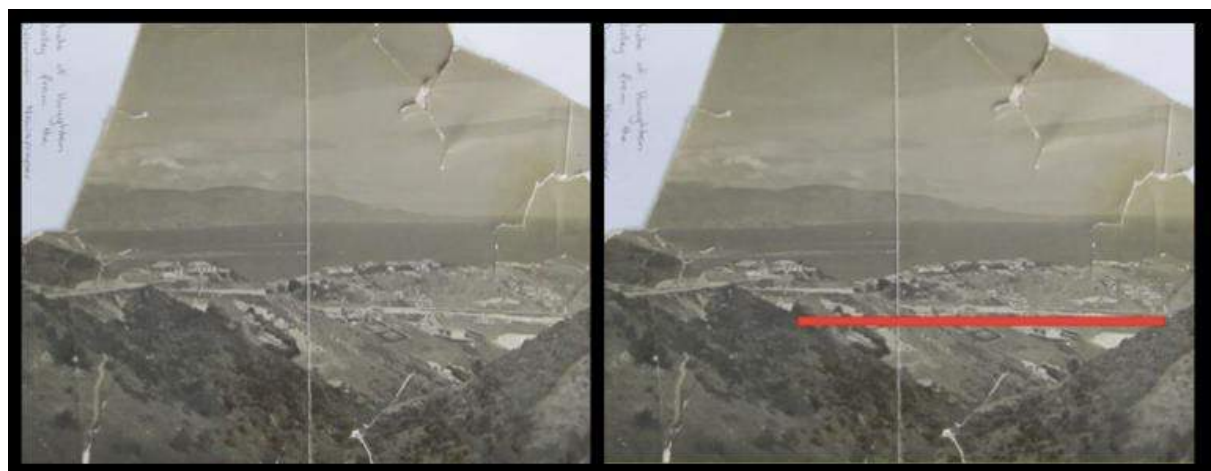
The original valley was steep and sustained a massive amount of landfill.

The landfill of this area began in the 1950s and was completed in 1971.

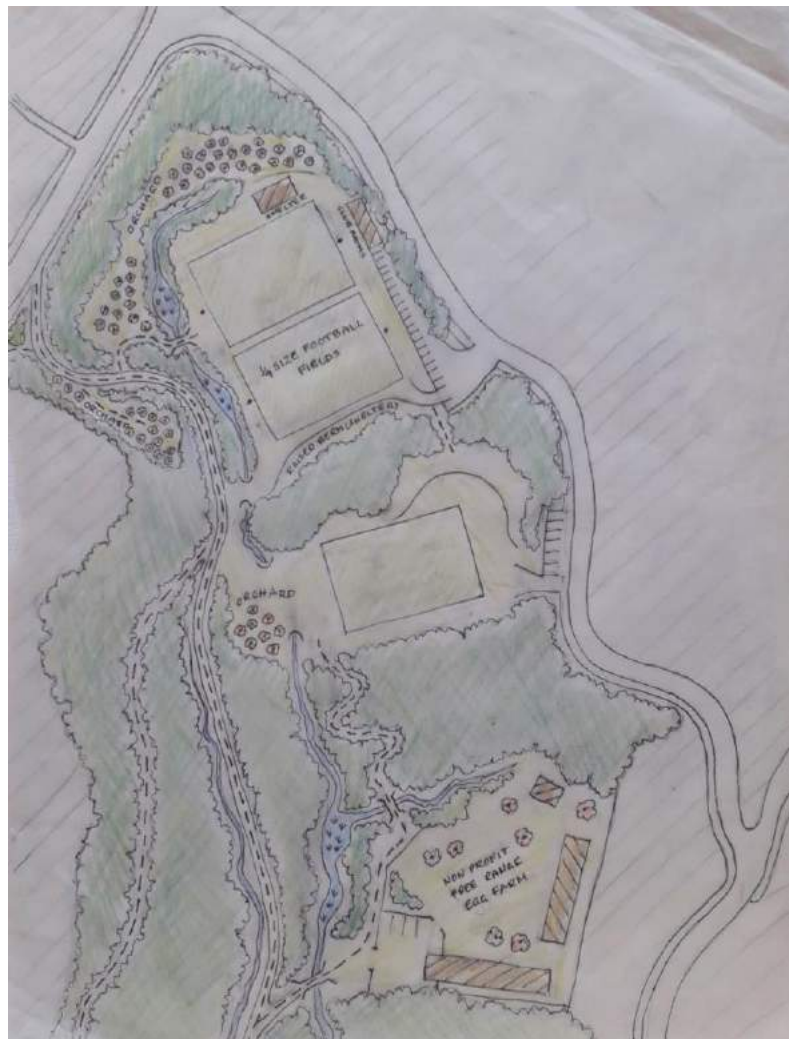
- Turning the boggy area into a proper wetland that captures the overland water, and the stormwater from the roads and drains the sports fields, before releasing it down a channel to the horse paddock;
- Creating an earth berm with planting to provide wind shelter and building a shelter for spectators;
- Planting the sunny and sheltered slopes with fruit trees for local food resilience.
- A free range egg farm instead of the horse paddock in the future?

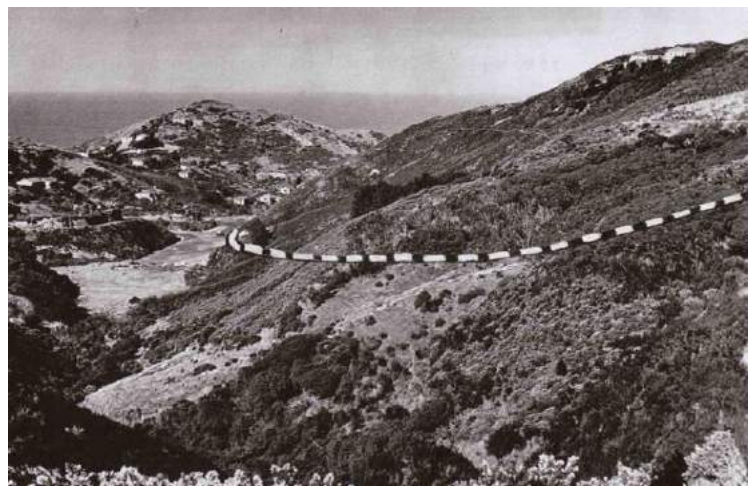
Going down to the school, there are sites of early houses, one now buried, and a stand of original manuka. The track was originally called Clonmel Road (see dotted line), from an early subdivision plan. If we didn't have the landfill, the valley may have been carved into sections and built on. Who knows what would have happened?

Carved channels show where the overland water is making its way down the valley. Any actual springs are truly buried and lost.

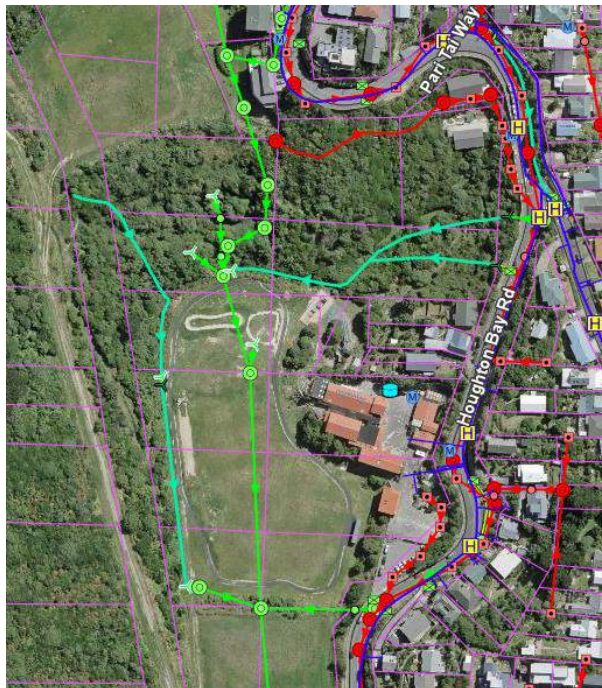
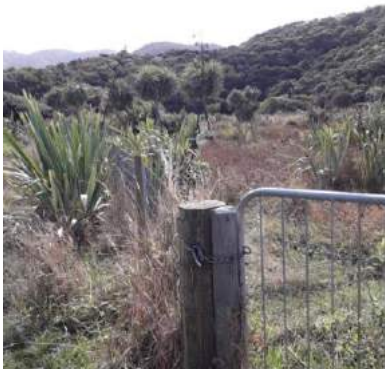
The blue-green lines show the overland water channels. These can be the basis for a new stream channel, with wetland areas to regulate the water flow. Fencing can protect both children and wildlife, such as has been done on top of the landfill in Tawatawa Reserve.

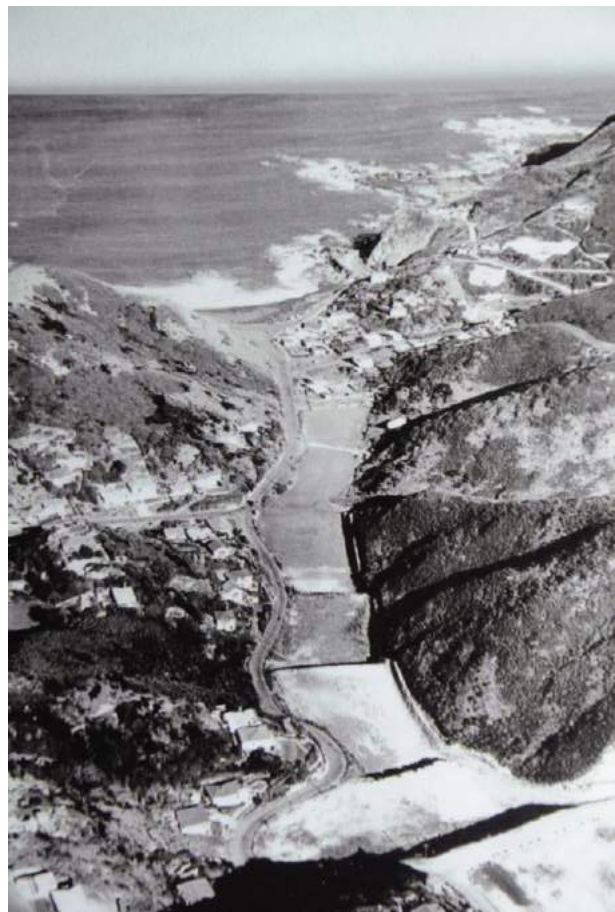
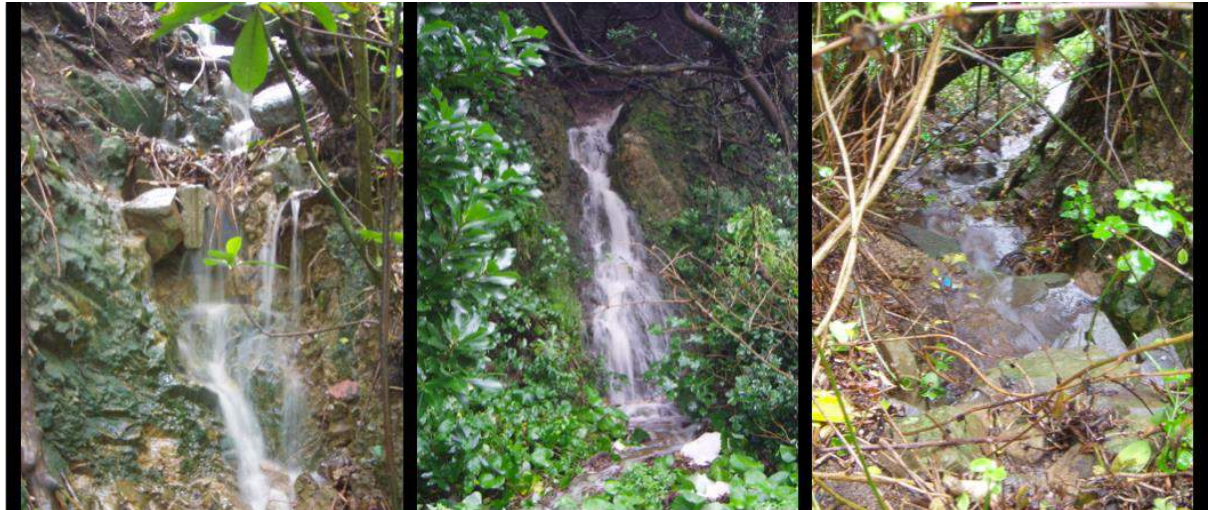
Overland water after heavy rain

Hidden away at the western edge, the overland water after heavy rain flows through part human-made, part naturally made channels, including cataracts and waterfalls over the dump faces.

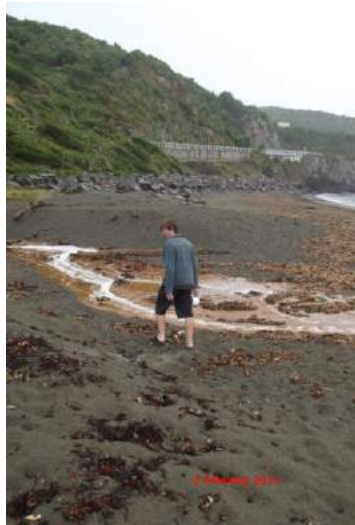
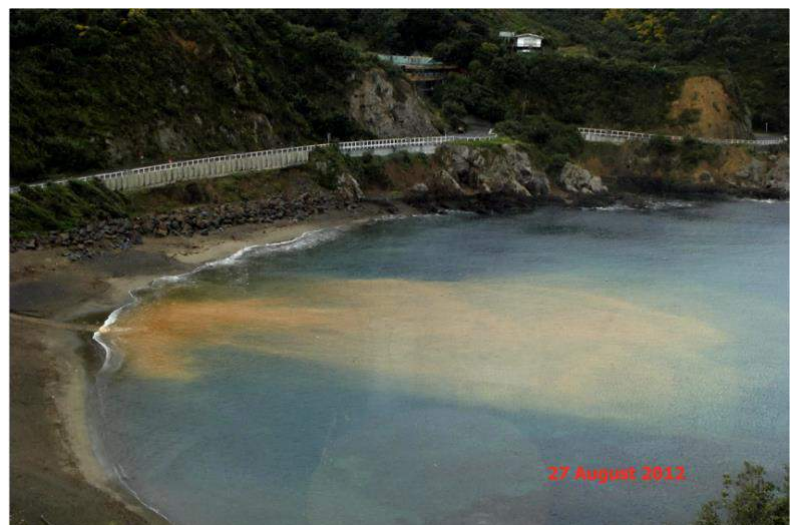
Report of contaminants in Houghton Bay

The beach is where the landfill damage is most visible, and rusty, contaminated water regularly taints the sand and the sea water in the Taputeranga Marine Reserve.

The pipe system is meant to divert the leachate water to the sewer, but 30mm of rain will over top the diversion weir and send everything down to the beach. Oddly enough, the worst contamination doesn't coincide with heavy rain, it is often just before rain and after a dry spell.

Test	Method	Result Unit	1 Tip Leachate Sample
Cadmium	APHA 3125	mg/l	0.00068
Chromium	APHA 3125	mg/l	0.010
Copper	APHA 3125	mg/l	0.050
Iron	APHA 3125	mg/l	125
Lead	APHA 3125	mg/l	0.042
Mercury	APHA 3125	mg/l	<0.0002
Selenium	APHA 3125	mg/l	0.0040
Zinc	APHA 3125	mg/l	0.82
